MICROBIAL INVESTIGATION REPORT

Clinton Middle School
34 Grayrock Road
Clinton, NJ 08809

Date of Inspection: 8/31/2018 &
9/8/2018

Project Number: 181023

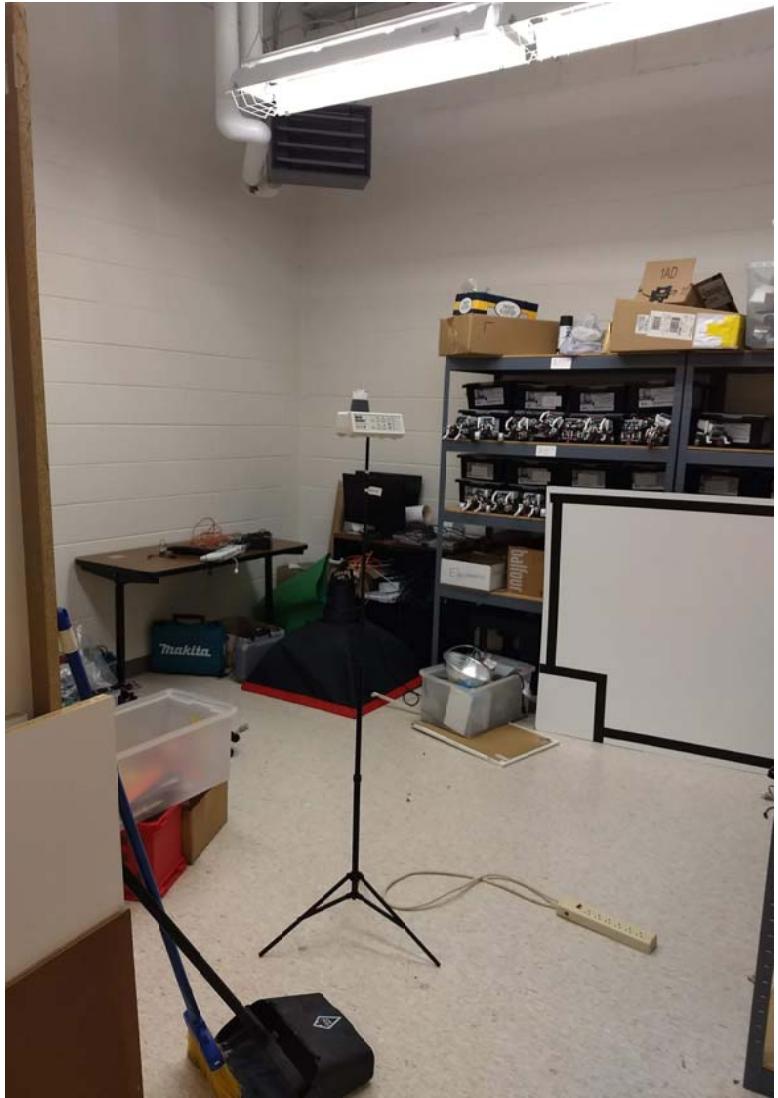
158B Storage Room

No suspect mold growth was observed in 158B storage room. Relative humidity of the space was 72.2% and temperature was 74.8 °F.

A spore trap air sample was collected from breathing height in the middle of room 158B Storage room (181023-2). The laboratory results of the air sample did not indicate a presence of elevated spore levels.

No suspect mold growth was observed in the storage room of 158B.

A humidity reading was taken at 72.2%. Based on the findings and laboratory results, it is LEW Corporations opinion that any suspected mold growth was not impacting these areas at the time of the investigation unlike the previous investigation on August 31st, 2018. A possible contributing factor could be associated to the elevated relative humidity level and lack of ventilation within the space.

LEW Corporation recommends a thorough cleaning of the storage room and maintain indoor relative humidity levels between 30% and 60% based on EPA recommendations.

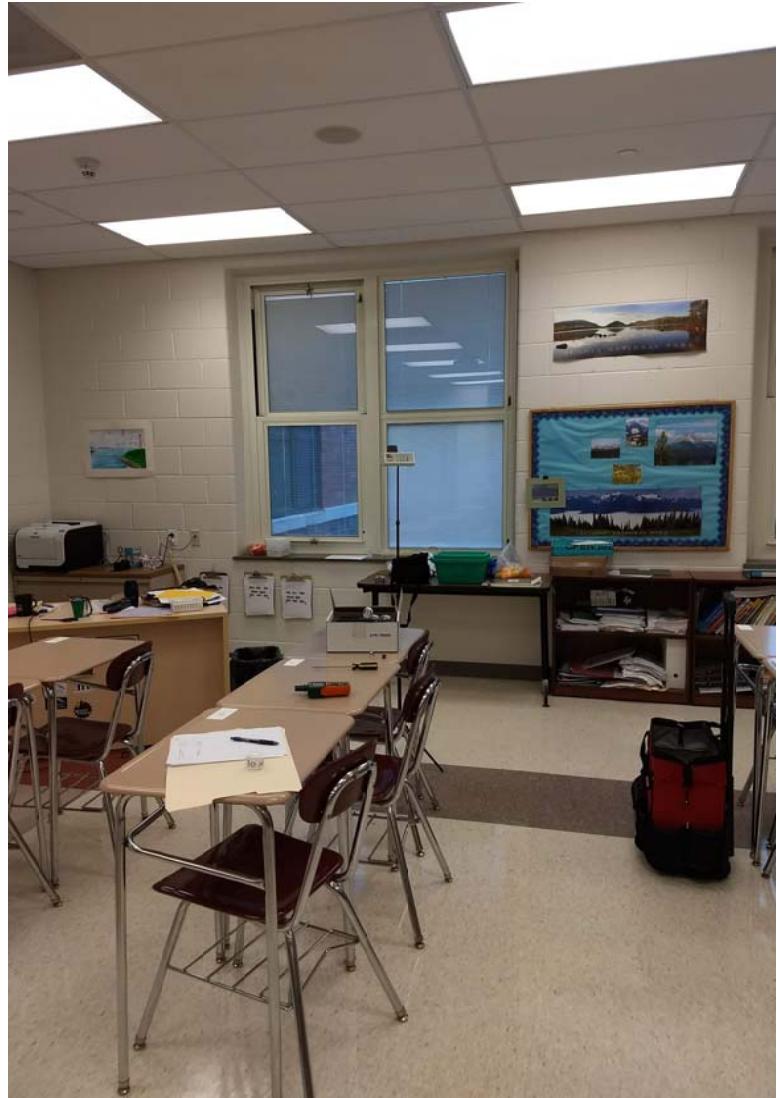
158B Main Classroom

No suspect mold growth was observed in 158B main classroom. Relative humidity of the space was 72.6% and temperature was 73.9 °F.

A spore trap air sample was collected from breathing height in the middle of room 158B (181023-1). The laboratory results of the air sample did not indicate a presence of elevated spore levels.

No suspect mold growth was observed in room 158B.

A humidity reading was taken at 72.6%. Based on the findings and laboratory results, it is LEW Corporations opinion that any suspected mold growth was not impacting these areas at the time of the investigation and remediation is not necessary. An attributing factor that could potentially be related to a fluctuation of mold spores in the space could be due to the elevated relative humidity.
